Venaseal™ Cyanoacrylate Glue Rejection Following Endovenous Ablation - Another New Complication

PS Lew¹, YK Tan¹, TT Chong² and TY Tang*²

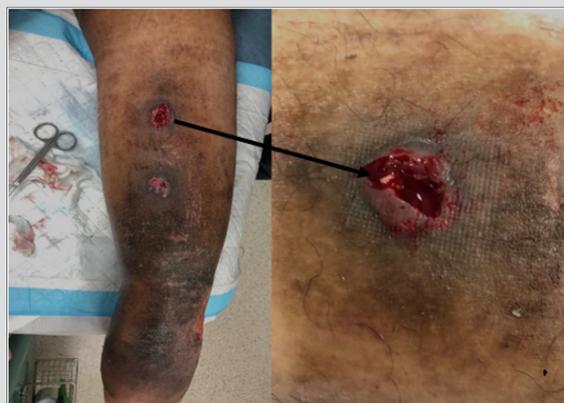
Figure 1: Left panel shows wounds on the calf following Venaseal ablation and glue cast is visible on the wounds overlying the LSV. Right panel is a close-up of the wound showing a frond of CAG protruding from the underlying great saphenous vein.

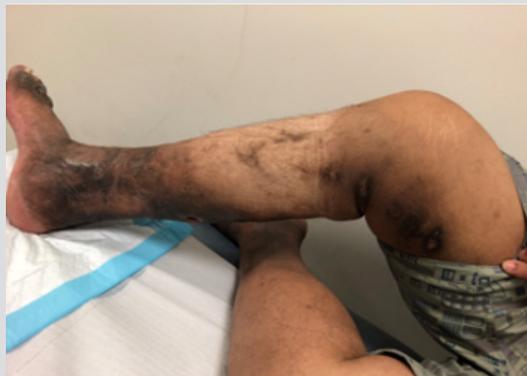
Figure 2: Multiple healed wounds along the distribution of GSV. Those wounds were extruding glue casts and took about 8 months to heal completely.

The VenaSeal™ closure system (Medtronic, Minnesota, USA) is a medical tissue adhesive containing n-butyl-2 cyanoacrylate, injected endovenously to treat varicose veins and superficial chronic venous incompetence (CVI), resulting here in a new treatment-related complication. This 42-year-old Malay male underwent endovenous ablation of the right great saphenous vein (GSV) and small saphenous vein (SSV) in November 2017 with the device for CEAP 6 disease. He had no previous drug allergies. The procedure was uneventful but unfortunately he started developing multiple painless large 'pustules' with surrounding erythema along the treated GSV and SSV 2 weeks post-operatively. This was initially thought to be a phlebitic type reaction, which is common side-effect after this procedure [1]. The patient was treated with anti-inflammatories and antibiotics assuming an element of underlying infection. However, his infection markers were never raised. All the pustules eventually burst and to our surprise pieces of white glue casts were seen from each wound (Figure 1). Histology of the glue cast showed degenerative inflammatory debris [2]. Subsequently, more glue casts were extruded periodically over the next 6-12 months until all the wounds were healed completely (Figure 2). Surveillance ultra

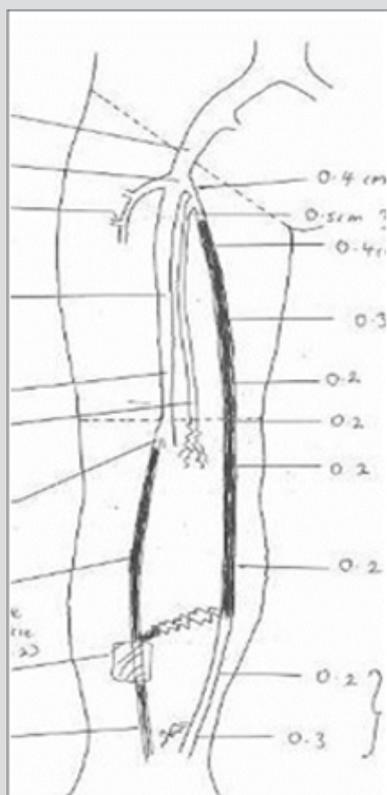
Figure 3: Venous duplex scan of right lower limb, 12 months after the Venaseal procedure, showing obliteration of GSV and LSV.

sound scan at 12 months showed that both GSV and SSV remained completely ablated (Figure 3). Patient remained asymptomatic from his treated CVI.
